Initial Feasibility Analysis Report

For Flood Control at Foxcroft Colony Condominiums and
Mosby Woods Condominiums, and Stream Restoration at Daniels Run

City of Fairfax, Virginia

May 2013

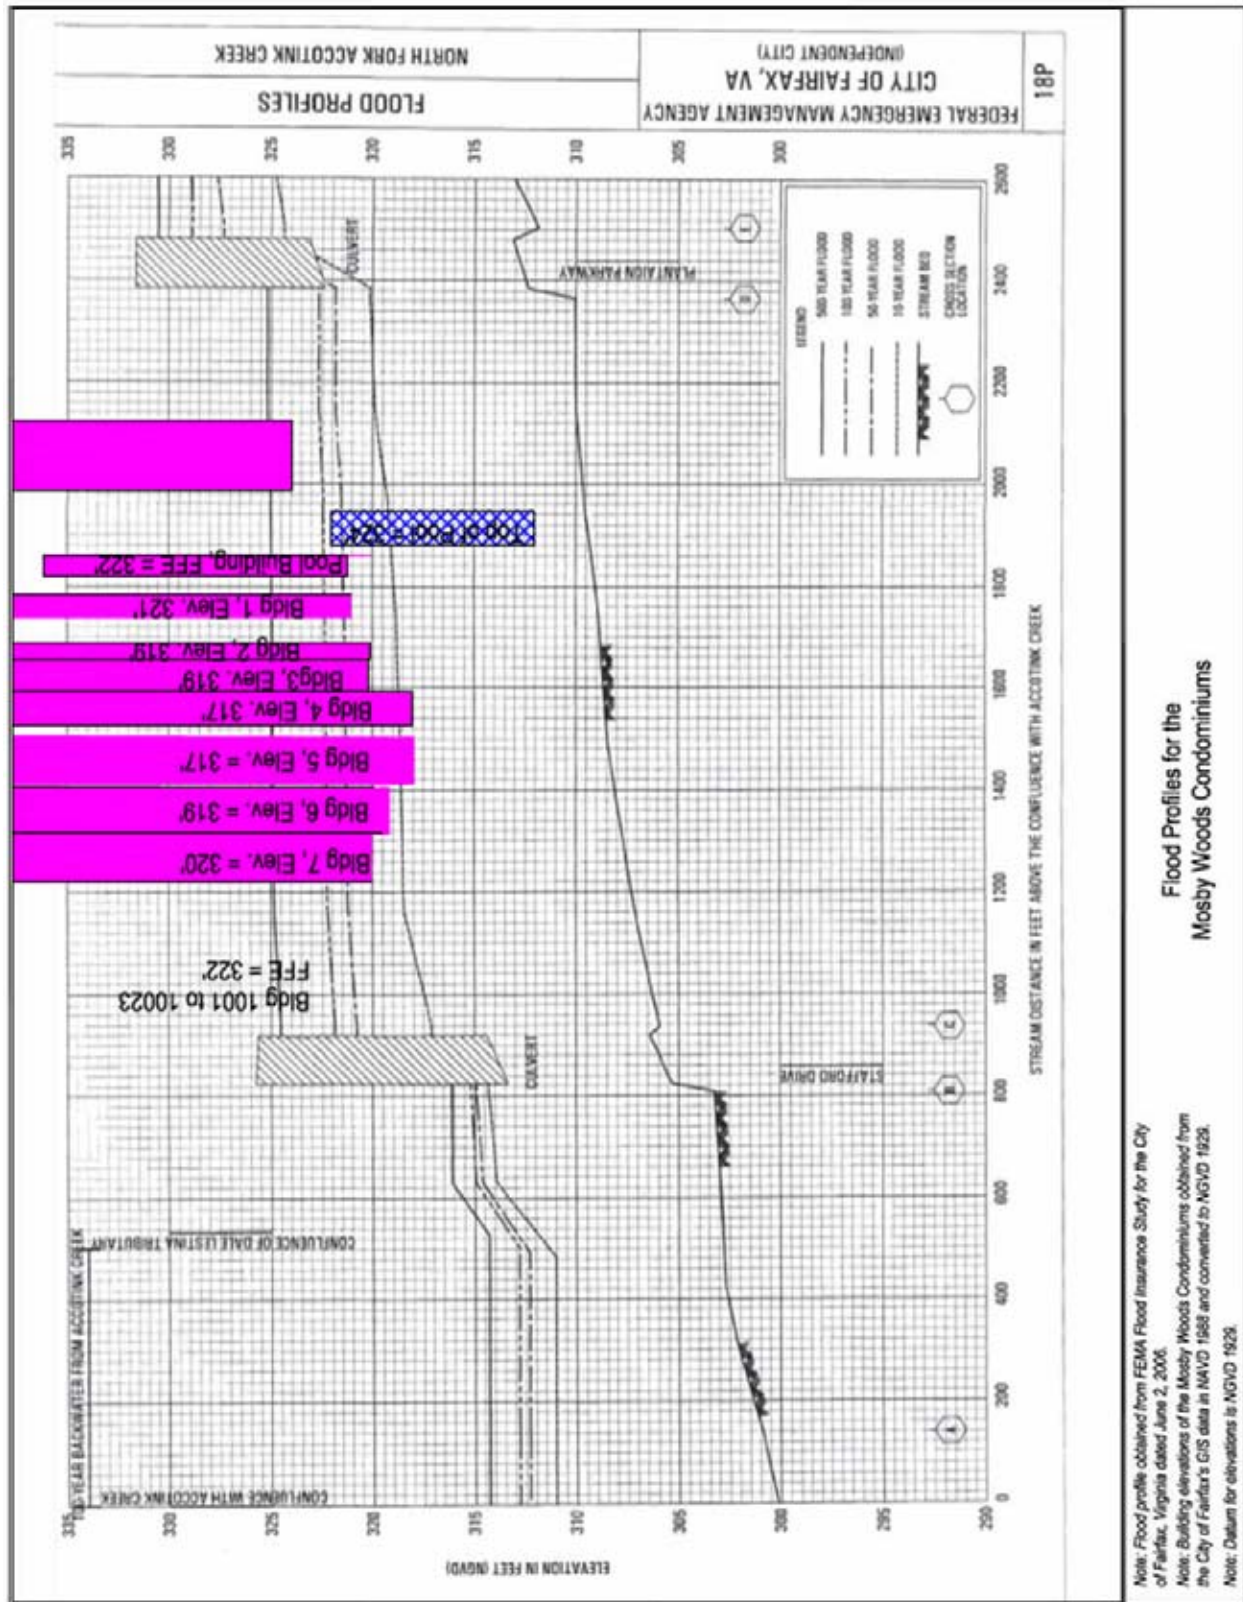
Figure 4-5. FEMA Flood Profile for North Fork Accotink Creek with Mosby Woods Condominium Buildings

As discussed in Section 2.6, it is estimated that Hurricane Sandy (2012) is between a 10-year and 25-year, 24-hour event. Tropical Storm Lee (2011) and closely resemble a 100-year, 12 hour event and the unnamed tropical cyclone (2006) is between a 10-year and 25-year, 24-hour storm event. Tropical Storm Lee and the unnamed tropical cyclone both caused flood damage, as predicted by the FIS flood levels. Hurricane Sandy floodwaters, on the other hand, were observed on the grounds close to, but not entering units; the predicted conditions in the FIS (that flooding would occur) does not match the Hurricane Sandy event conditions. One of the reasons that units were not inundated from Hurricane Sandy flood waters is that residents prepped for the storm using and engaged in floodfighting activities.

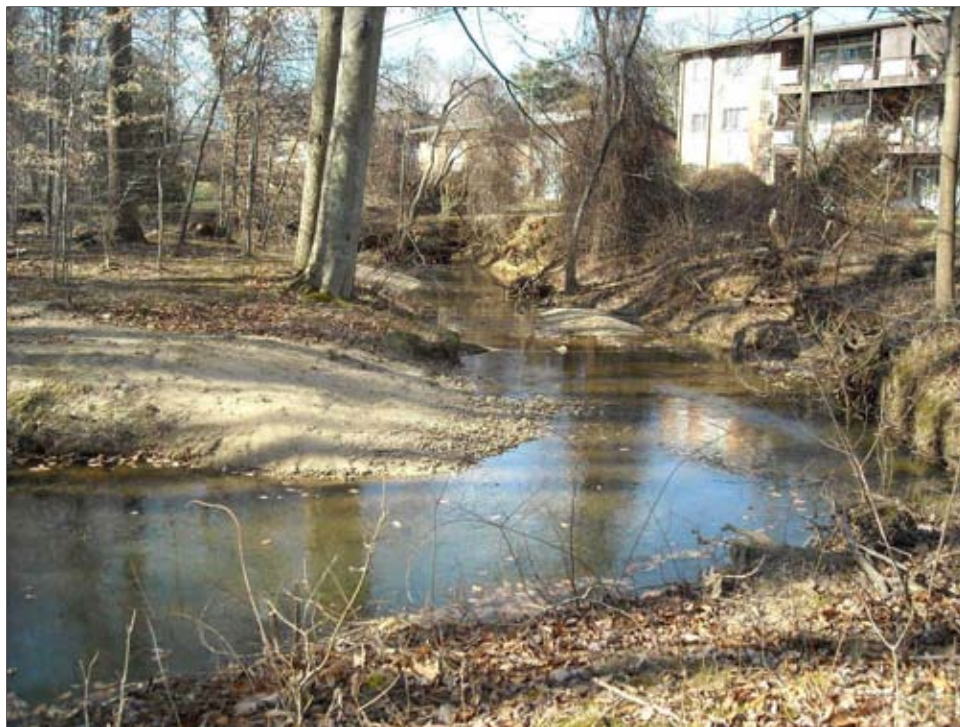
Figure 4-6. “Horseshoe” Bend in North Fork Accotink Creek at Mosby Woods Condominiums

URS personnel performed field reconnaissance in January 2013 to investigate conditions of the Mosby Woods study area. During this investigation significant erosion was noted along the banks of North Fork Accotink Creek. A resident who has lived at Mosby Woods for over 20 years indicated that the creek has changed from relatively straight to a “horseshoe” shape, as shown in **Figure 4-2**. Pictures of the current state of the creek, as of January 2013, are displayed in **Figure 4-6** and **Figure 4-7**.

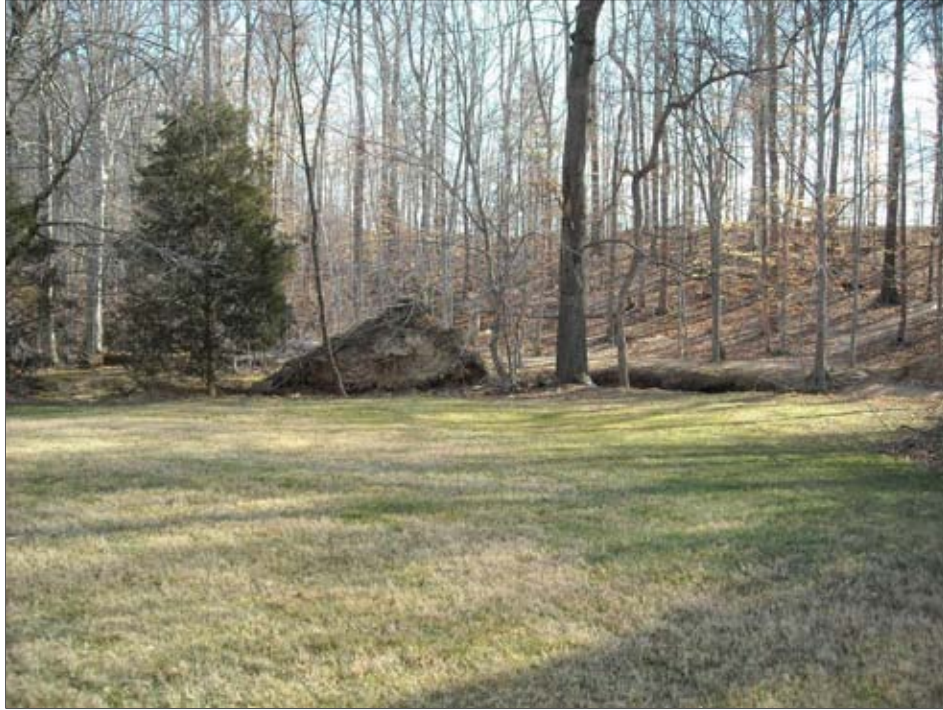
Figure 4-7. Fallen Tree Due to Heavy Bank Erosion at Mosby Woods Condominiums

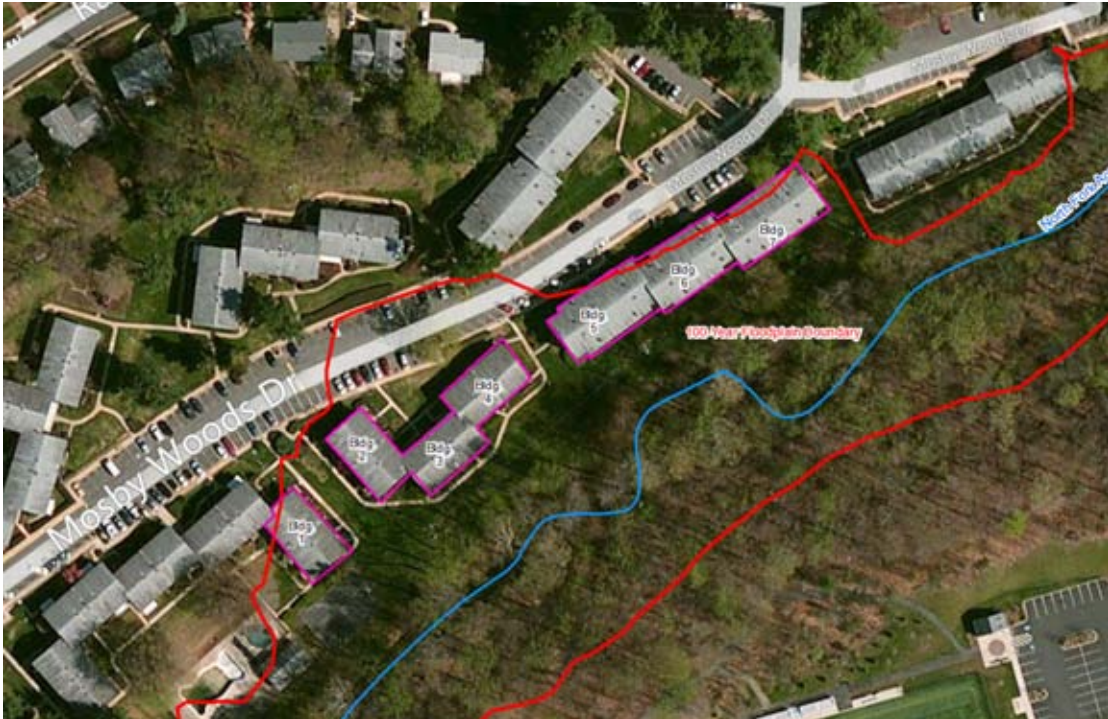
Figure 4-8. Mosby Woods Condominiums Buildings to be Flood-proofed

Proposed Alternative Plan 1 includes the measure of flood-proofing the buildings of Mosby Woods within the designated floodplain. Based on the effective FEMA FIRM, there are 18 first-floor condominium units in 7 buildings located in the 100-year floodplain. Refer to **Figure 4-8** for proposed flood-proofed buildings (outlined in magenta). During past flood events flood waters have entered these units through the unit's front doors, garden patio doors, windows and the common utility room doors, photos of typical entry points are provided in **Figure 4-9**. Floodwater has then traveled from units through interior walls to adjacent units on the first floor.

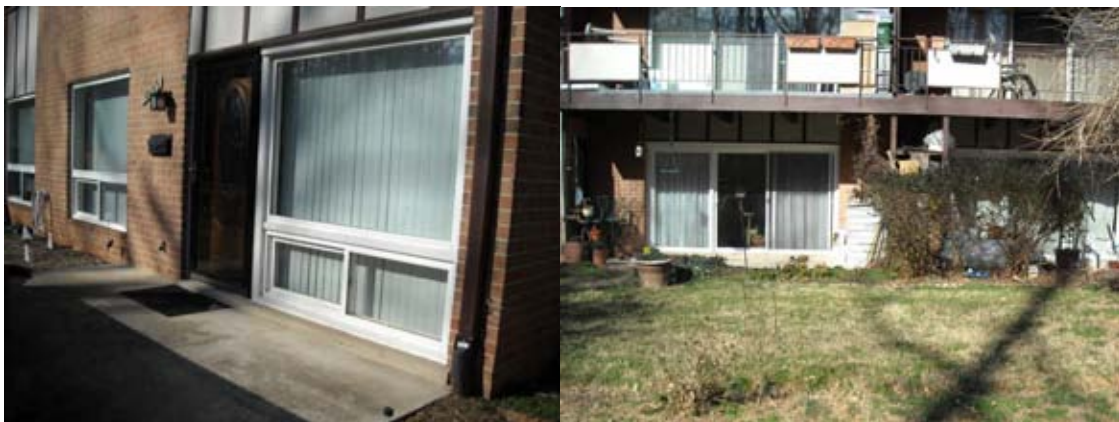
Figure 4-9. Mosby Woods Condominium Building Flood Entry Points

As mentioned previously in Section 3.5, the concept of flood-proofing typically involves sealing the exterior building wall with waterproofing compounds, impermeable sheeting, or other material and using shields for covering and protecting openings from floodwaters. Shields can be used on doors, windows, vents, and other openings. For this concept plan, a water proof membrane and protective covering would be applied to the exterior of the existing walls with the addition of flood barriers at the patio doors and windows and a water tight door at each building's common room entry door. Each of the buildings outlined in **Figure 4-8** are located within the 100-year floodplain and therefore are recommended for flood-proofing measures.

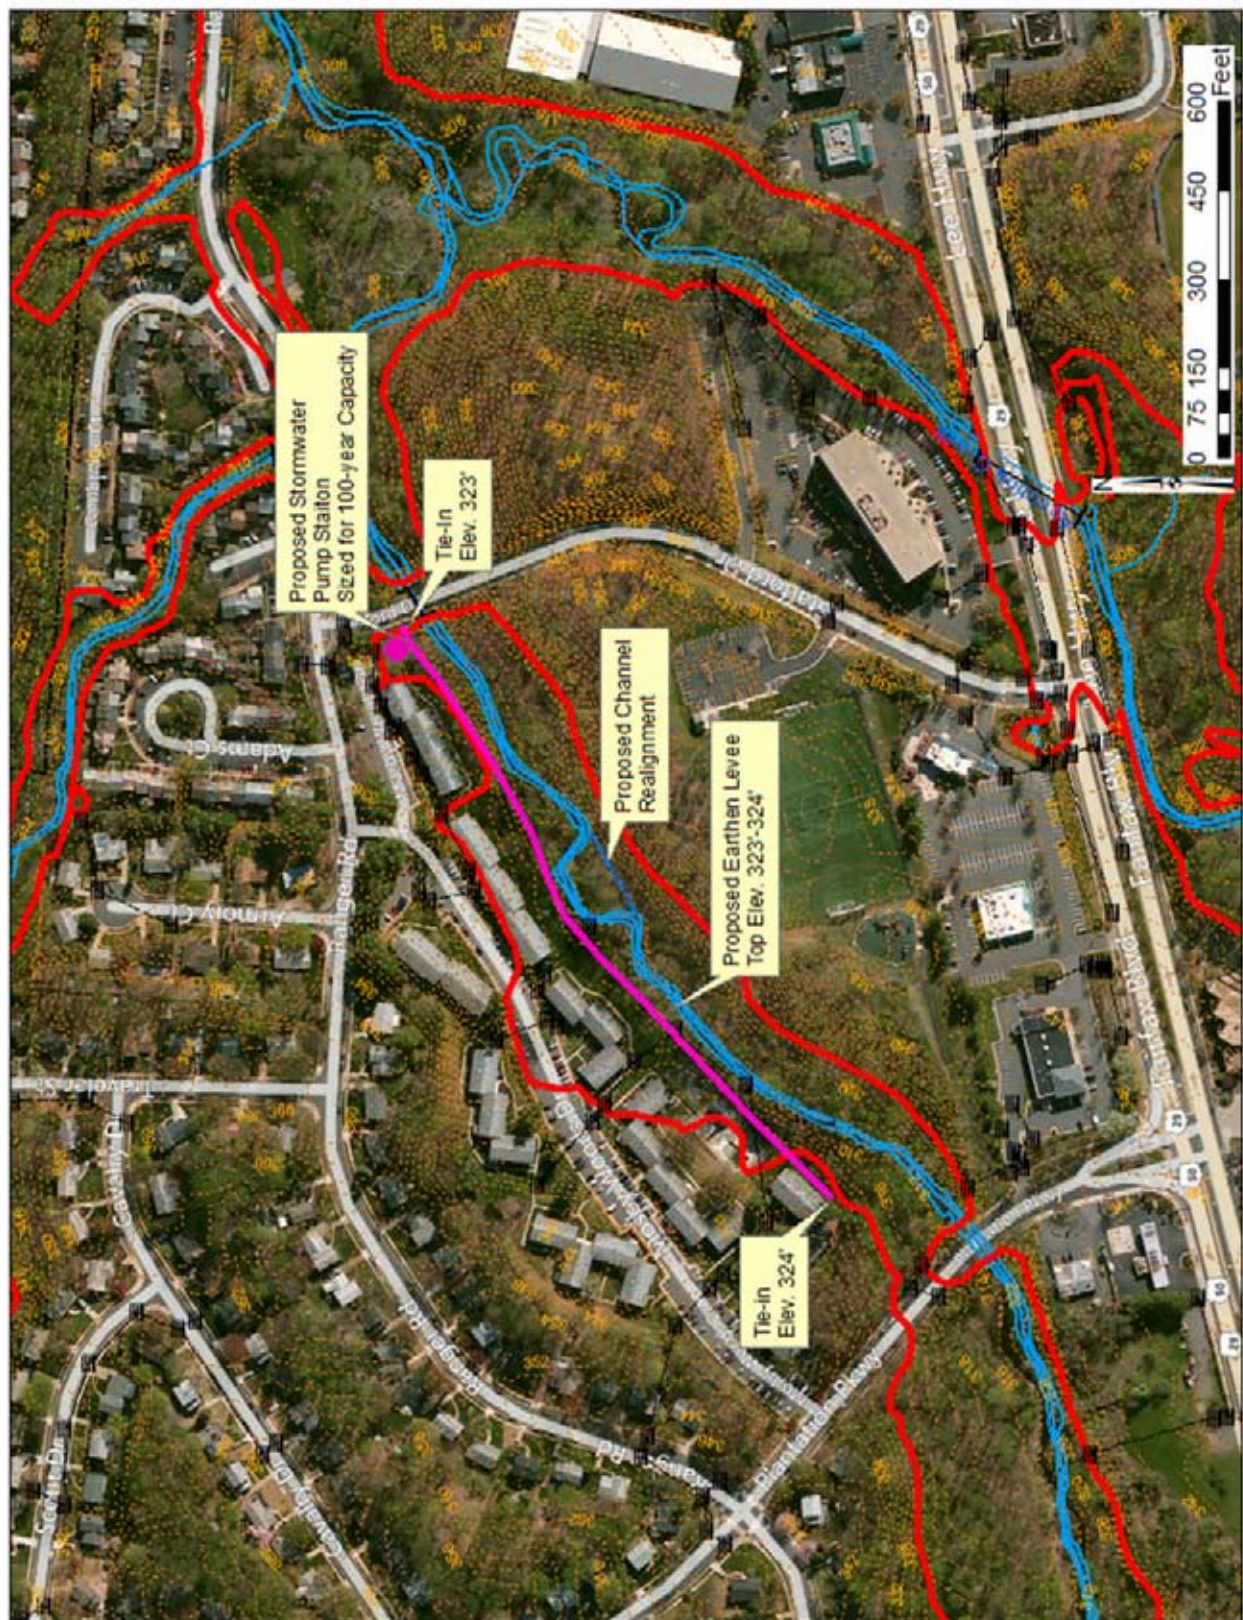
Figure 4-10. Proposed Conception Plan – Alternative Plan 2 Levee and Pump Station

Since the levee is proposed at an elevation one foot above the 100-year BFE, the proposed design would not meet FEMA certification requirements and the Mosby Woods residents in the floodplain would still be required to purchase flood insurance.

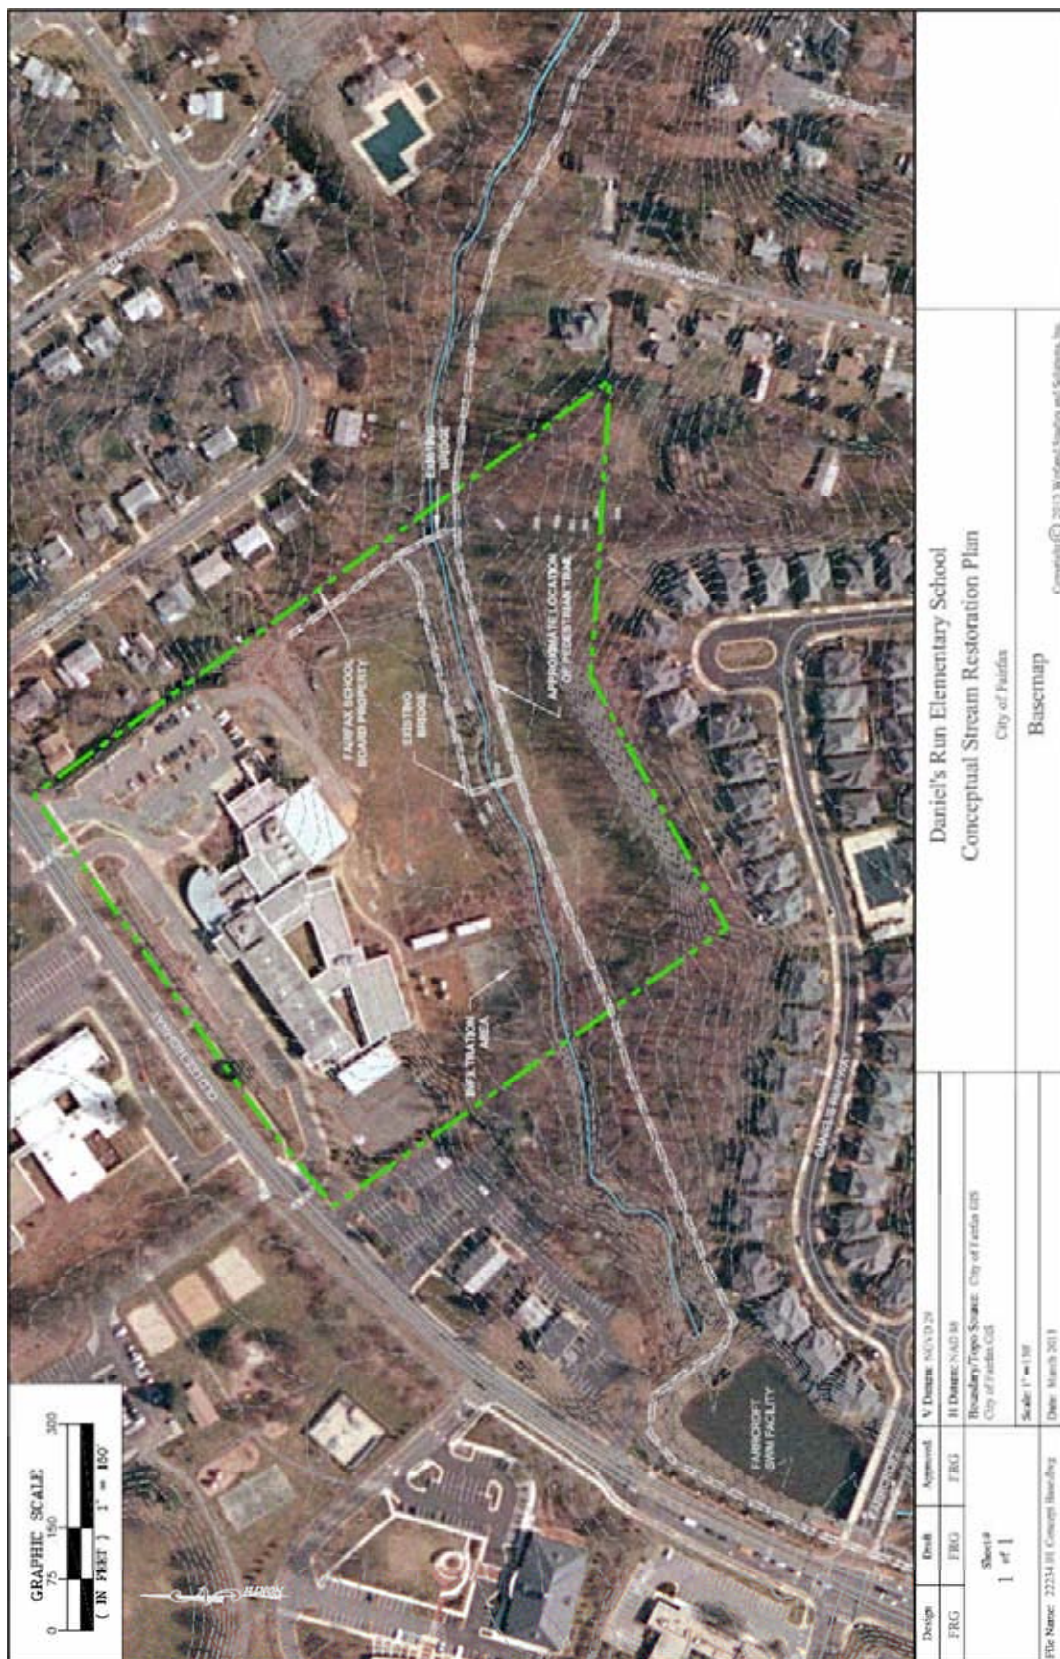
Figure 5-2. Daniels Run Elementary School Base Map

Daniels Run begins east of the intersection of Armstrong Street and George Mason Boulevard and flows in a northeasterly direction for approximately 13,700 lf before emptying into Accotink Creek on Army Navy Country Club property. The portion of the channel that is the subject of this study is located on the property of Daniels Run Elementary School, approximately 750 lf. A map depicting the contributing watershed to this point is presented in **Figure 5-1**. A more detailed base map of the subject reach is presented in **Figure 5-2**.

The property boundary depicted in **Figure 5-2** was obtained digitally from the City of Fairfax Geographic Information System (GIS). The section of Daniels Run, that is the subject of this study, is located entirely within the parcel, which is owned by the School Board. In a meeting held with school staff, URS learned that they have been very active in the planning and implementation of restoration measures within the subject reach, in conjunction with the-not-for-profit organization “Lands and Waters.” More information regarding the previous restoration work is provided in Section 5.4 below.

Additional information relating to the design of the upstream SWM facility in the community of Farrcroft can provide very useful information as flows in the subject reach are largely controlled by the outlet structure of the facility (location is depicted in **Figure 5-2**). Some of this information has been reviewed for this study, as discussed below.

The issue with this method is the increased width of necessary disturbance. This results in increased tree impacts and the potential for impacts to adjacent infrastructure (utilities, trails, fences, etc.). There is also a school project located along the north stream bank (see **Figure 5-2**) that was designed to

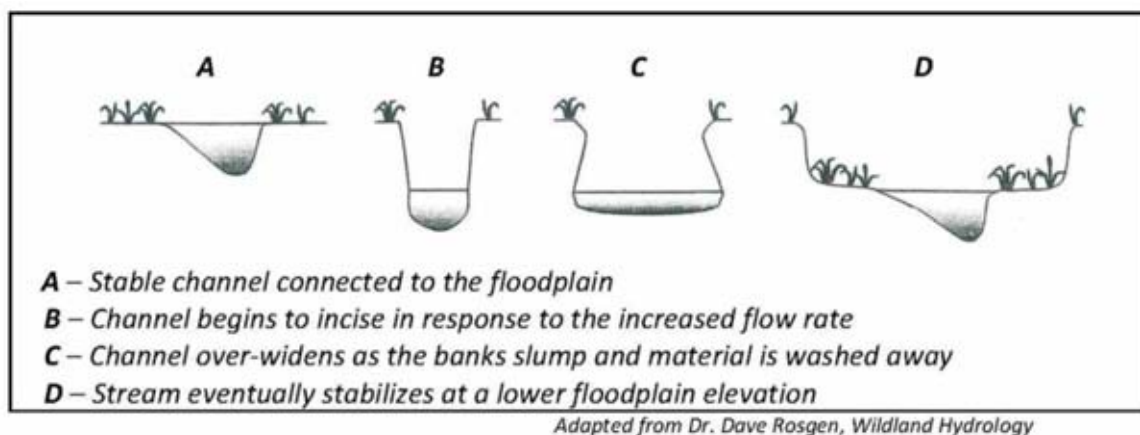
Figure 5-4. Illustration of Stream Degradation over Time

The reasons for the degradation experienced in Daniels Run are obvious when looking at the development of the contributing watershed. The aerial photos in **Figure 5-5a** and **Figure 5-5b** represent the land uses in 1937 and 2012, respectively, in the Daniels Run watershed. While the deforestation evident in the agricultural landscape of 1937 would have also had an adverse impact on the condition of the channel, the impacts caused by the 48% impervious cover seen today are likely many times worse. The result of this impervious cover (and resulting increase in runoff volume) is the degradation of Daniels Run that likely progressed in the fairly predictable manner depicted in the following evolutionary process shown in **Figure 5-4**.

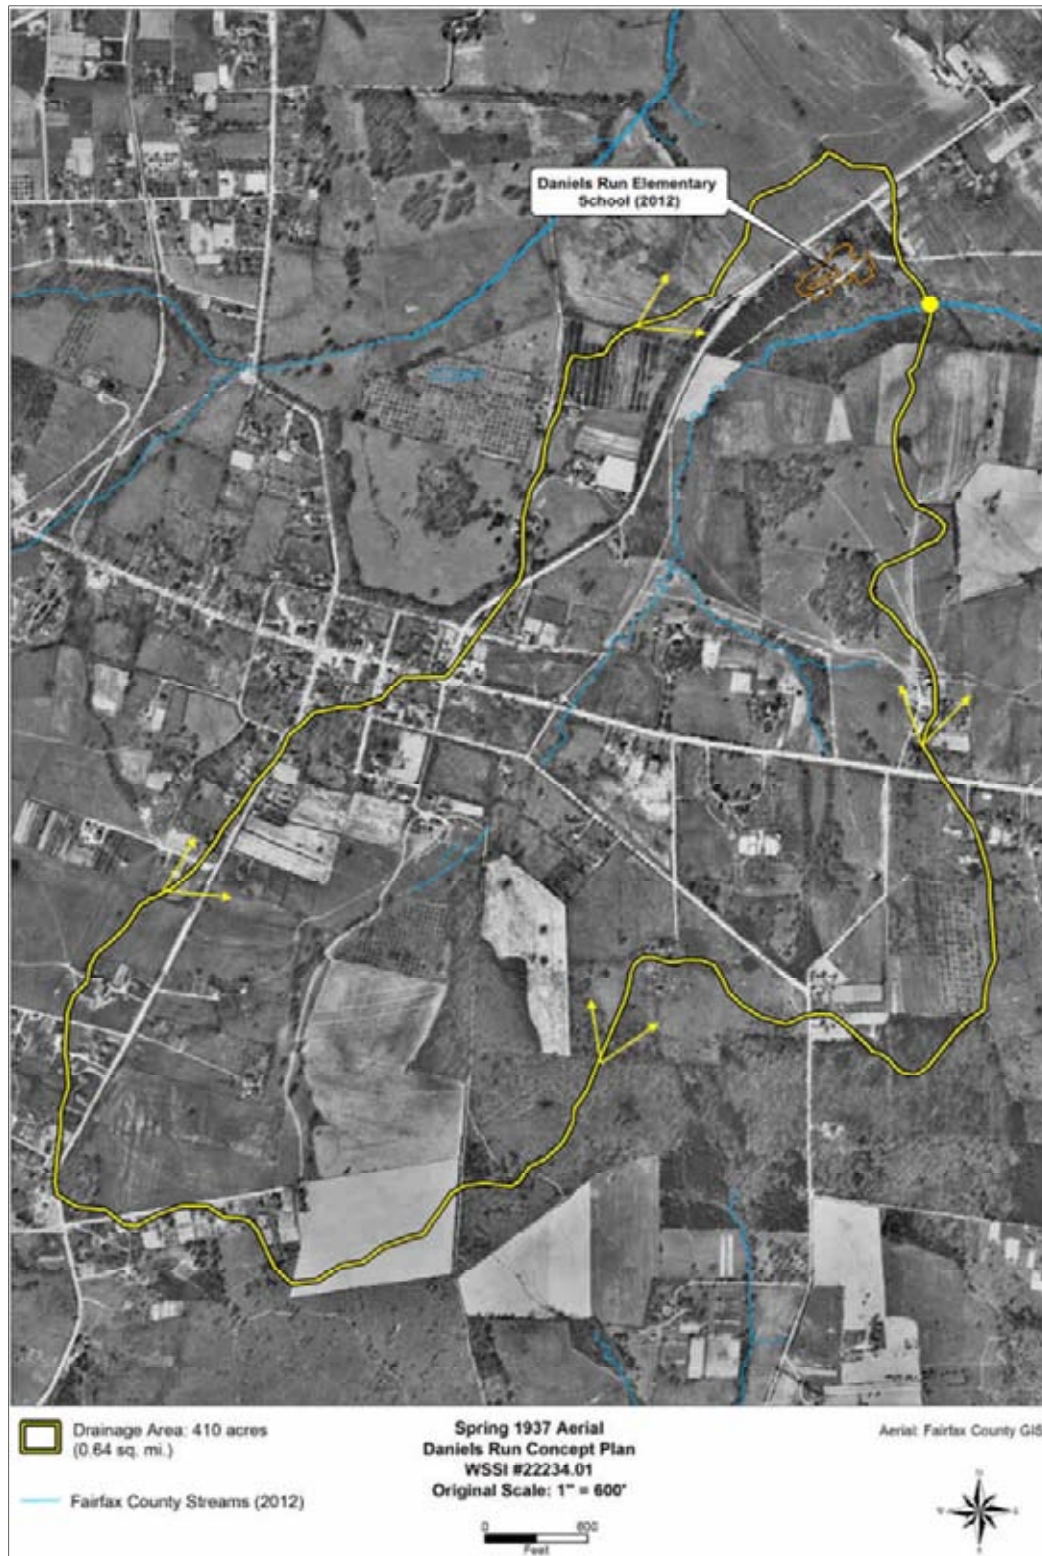
Figure 5-5a. Aerial Photograph of Contributing Watershed in 1937

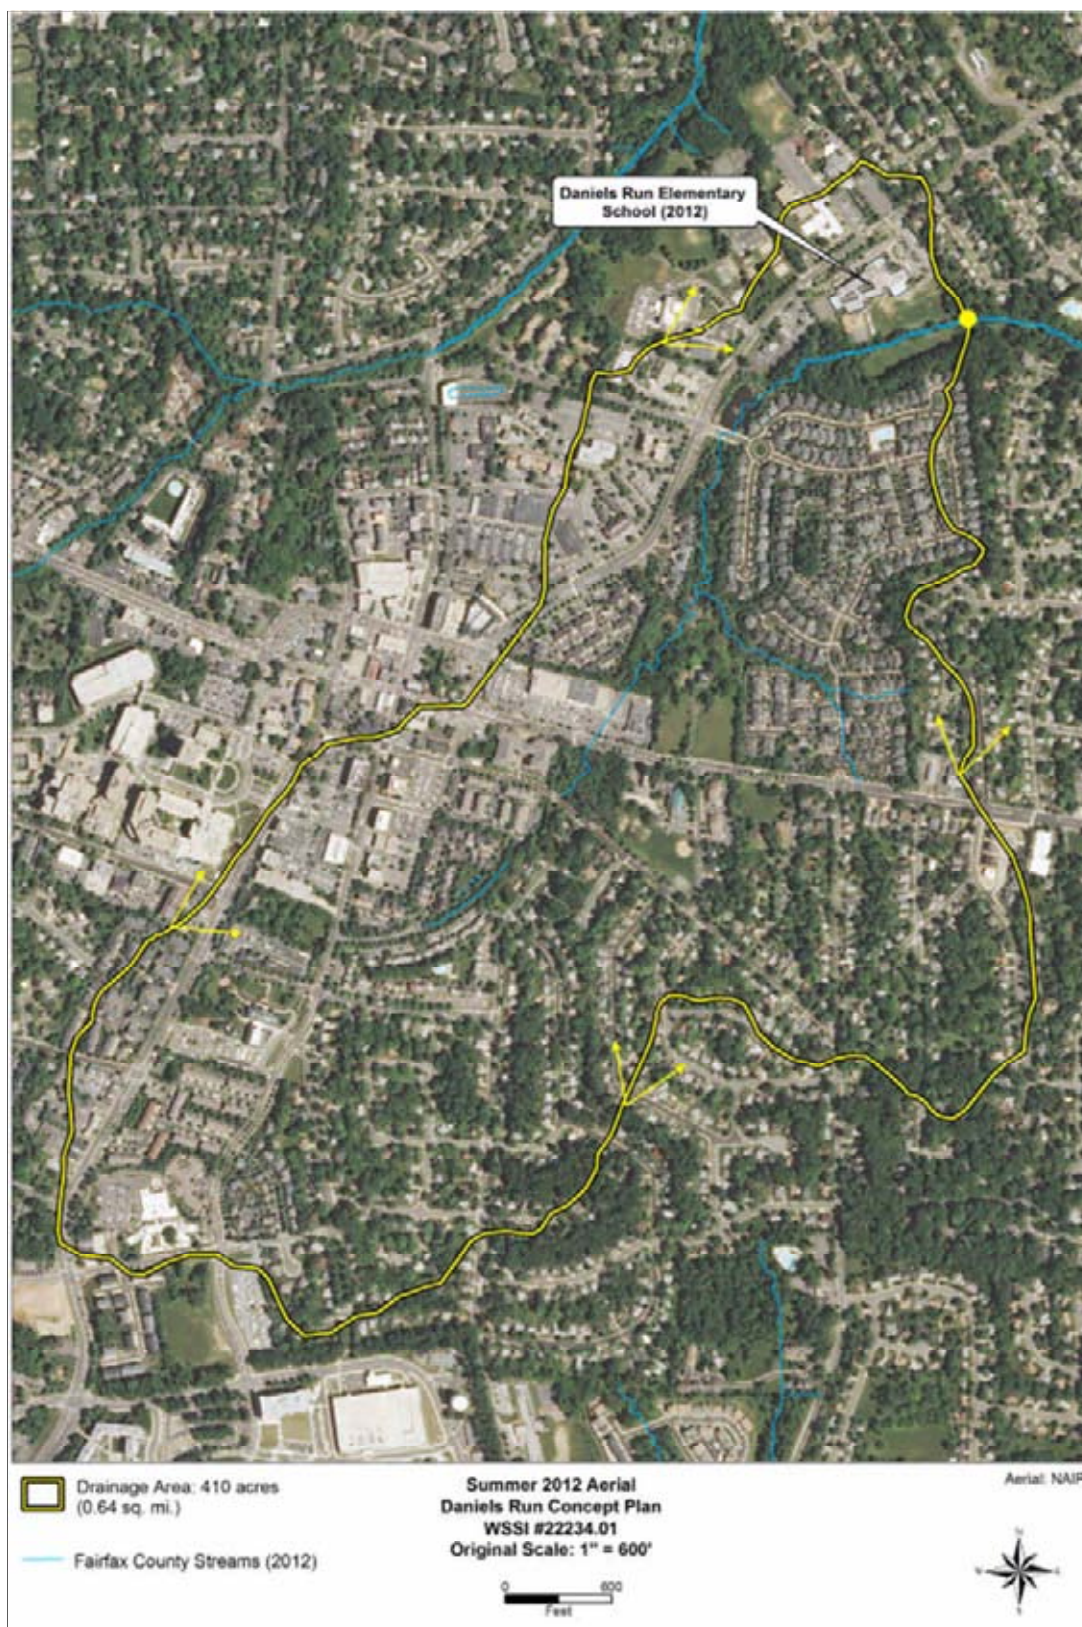
Figure 5-5b. Aerial Photograph of Contributing Watershed in 2012

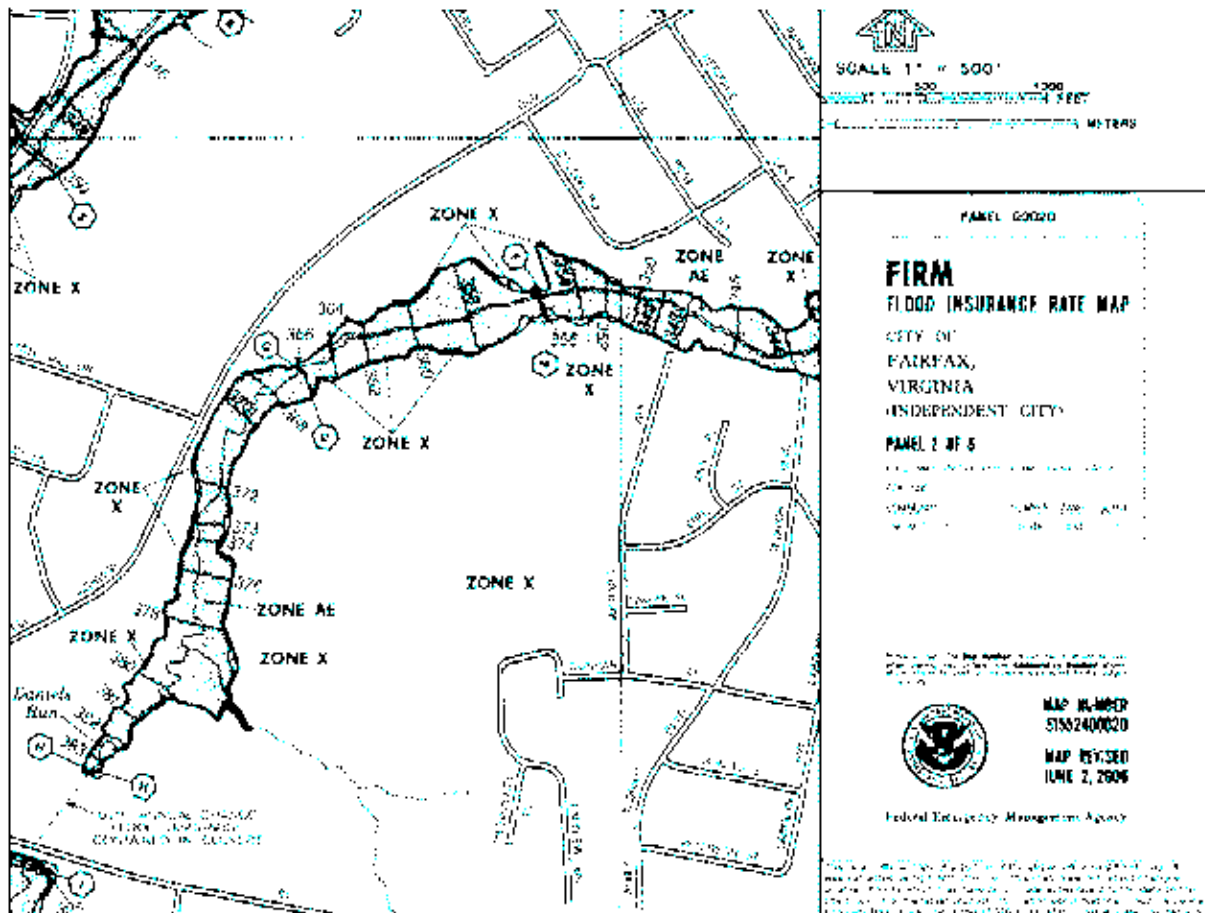
Figure 5-6. FEMA FIRM for Daniels Run Study Area

Daniels Run is designated as a FEMA floodplain. As such, detailed hydrologic/hydraulic studies have been performed and are described in the FIS for the City of Fairfax. An excerpt, from the FEMA study depicting the 100-year water surface elevation in the vicinity of the subject reach, is presented in **Figure 5-6** (near cross-section “F”).

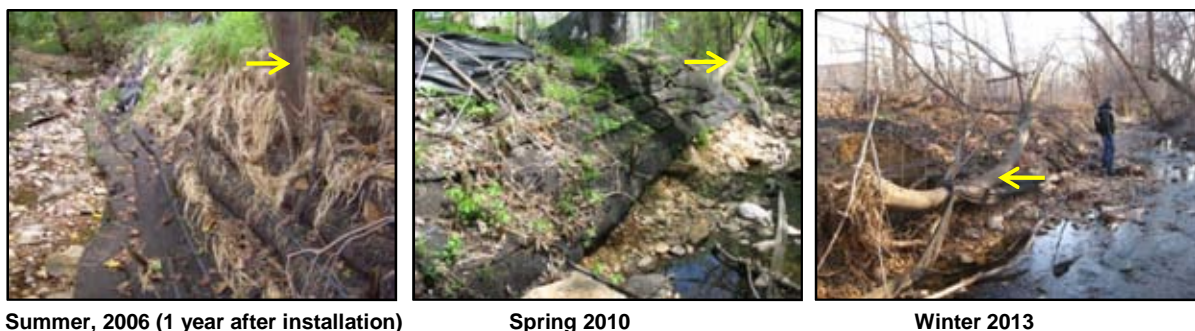
The theory behind this system is to provide a growing media within the fabric, Soxx™, to facilitate the establishment of vegetative growth. Over time, the roots of the vegetation reinforce and stabilize the eroding banks. However, this "softer" approach is susceptible to damage from storm flows, especially in deeply incised channels with steep banks such as those in the subject reach. In addition, the long-term strength of this system comes from the roots of dense vegetation growing through the Soxx™ and into the underlying stream bank. However, this growth was never achieved, likely due to the shade from the larger trees along the bank. The following progression of photos (**Figure 5-7**) chronicles how the system has degraded over time (the arrow identifies the same tree in each photo).

Figure 5-7. Previous Bank Stabilization Effort

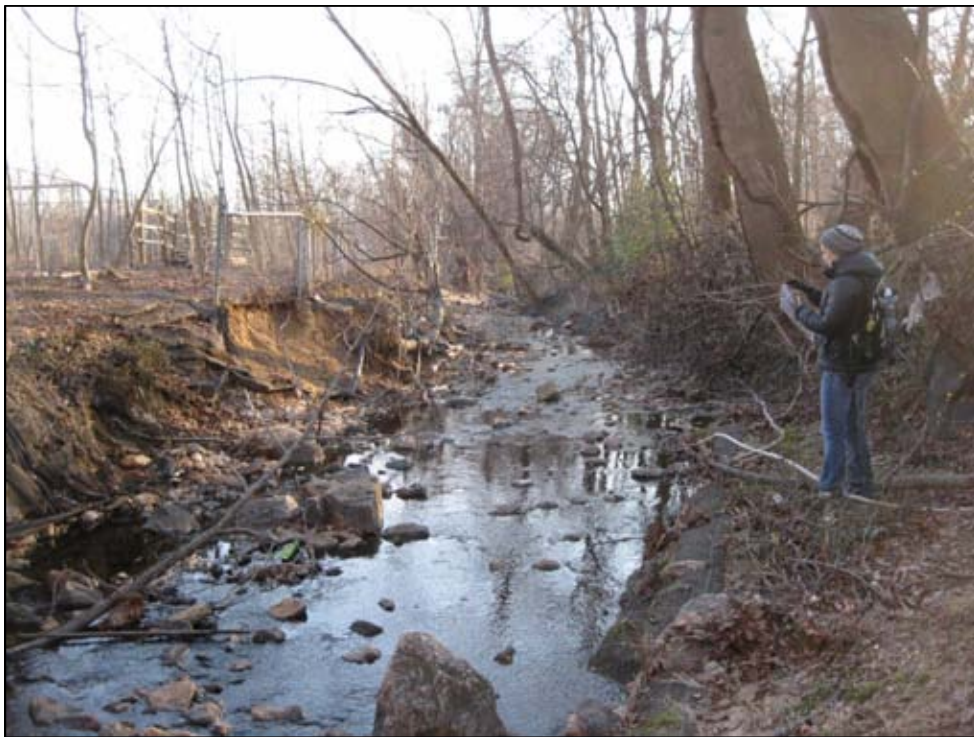
Note that there are some places within the subject reach where the cross-section is relatively stable, at least along one bank (an example can be seen in **Figure 5-8**). Areas like this may not need to be impacted as part of any restoration effort. However, vertical and/or eroding banks would need to be corrected in order to achieve a permanent and ecologically sustainable restoration.

Figure 5-8. Photograph from Field Investigation

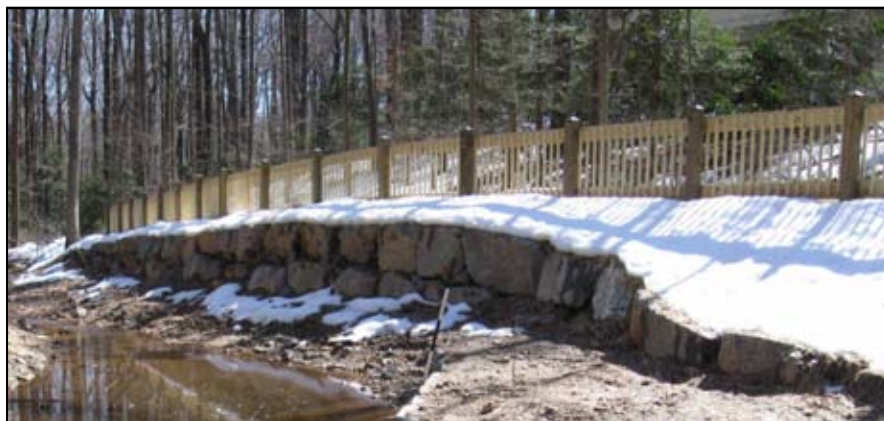
Figure 5-11. Stabilization in Place using an Imbricated Rock Wall

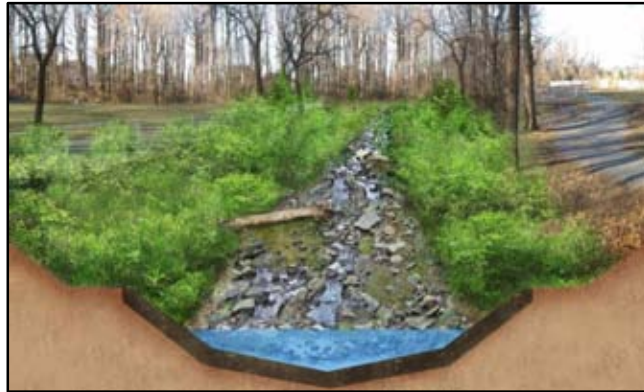
Figure 5-14. Rendering of Channel with Bankfull Bench

Figure 5-14 is a rendering of what the subject may look like after a couple of years should the multi-stage channel with the bankfull bench be constructed along the entire reach. Once again, this may

represent the “worst case” as some segments of the bank may be sufficiently stable to remain as they are. This will have to be determined after a detailed survey has been performed.

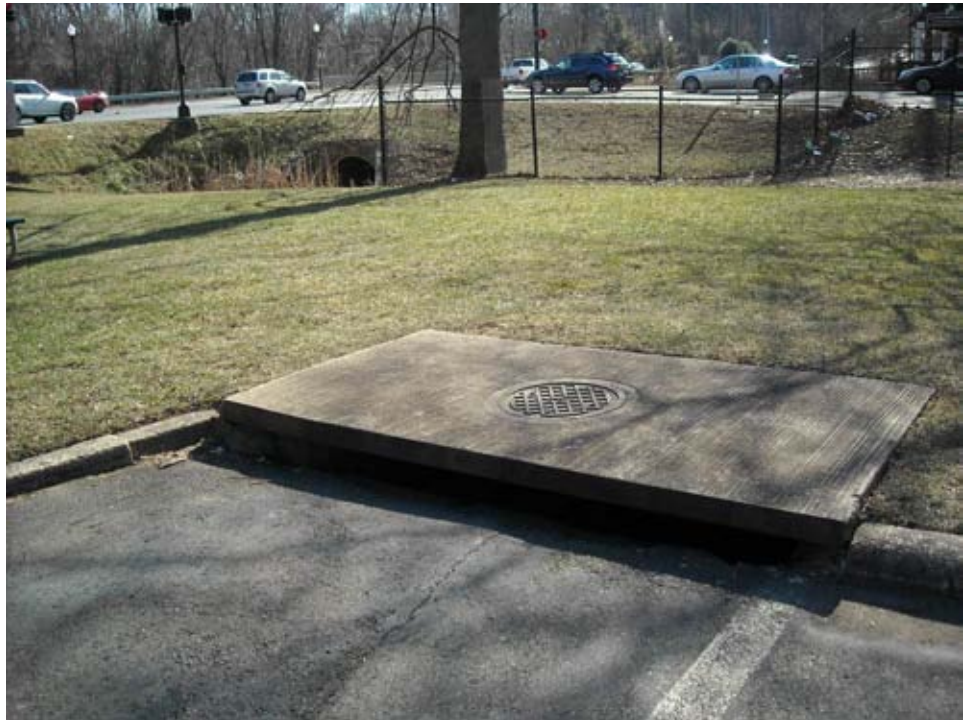
Storm inlet from the Foxcroft Colony Condominiums which leads to the culvert under Old Pickett Road.

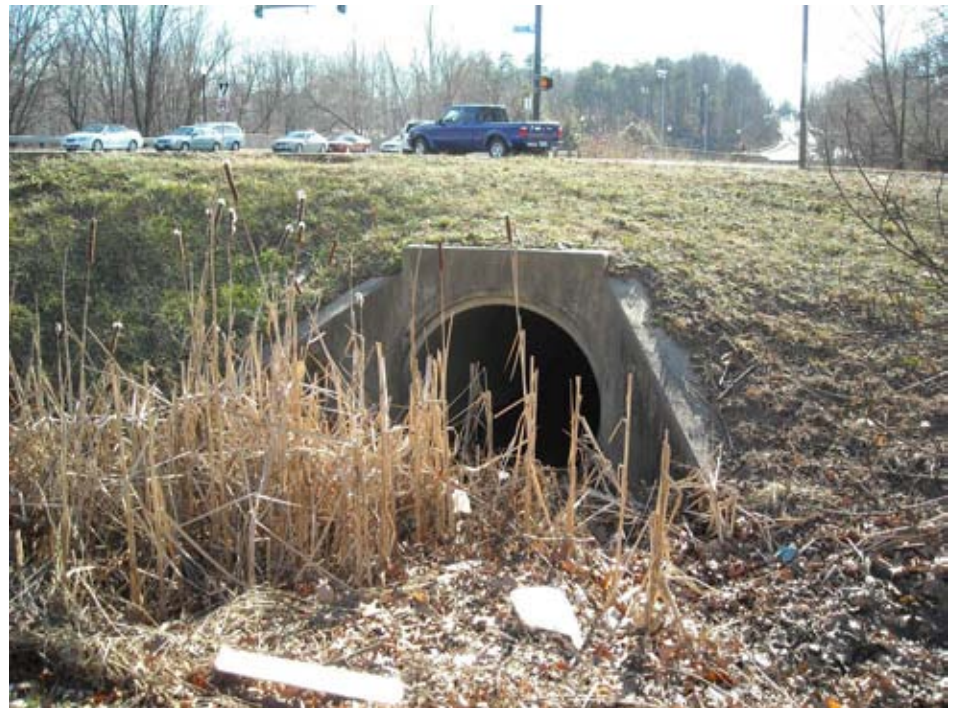
Culvert from the
Foxcroft Colony
Condominiums
under Old Pickett
Road (view from the
other side of the
street). Note,
cattails suggest
frequent standing
water.

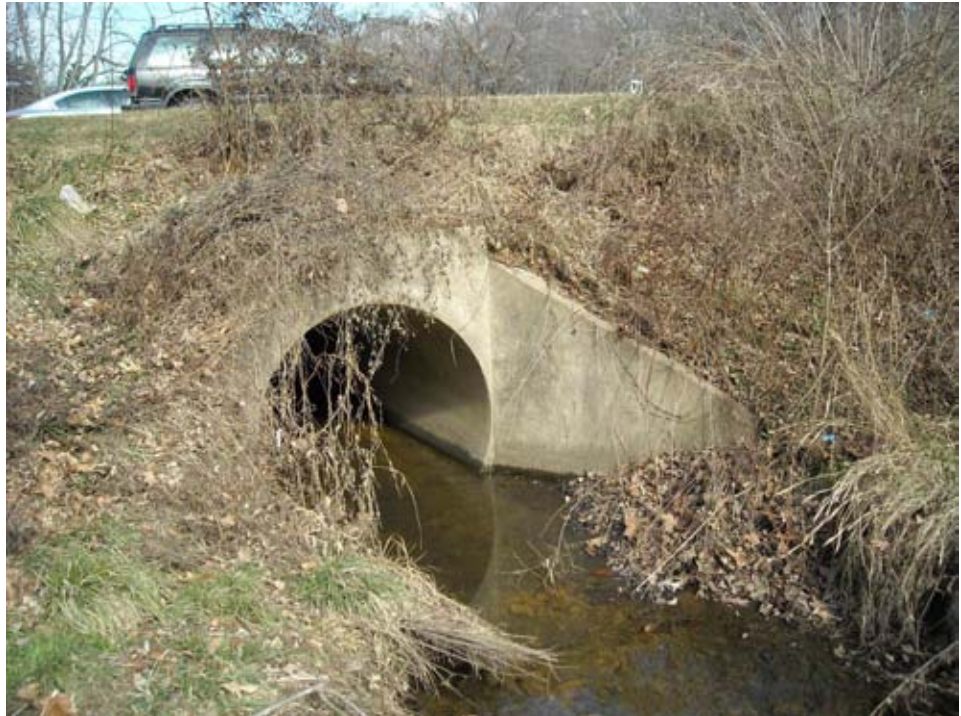
Photo 6

Culvert from the
Foxcroft Colony
Condominiums
under Old Pickett
Road.

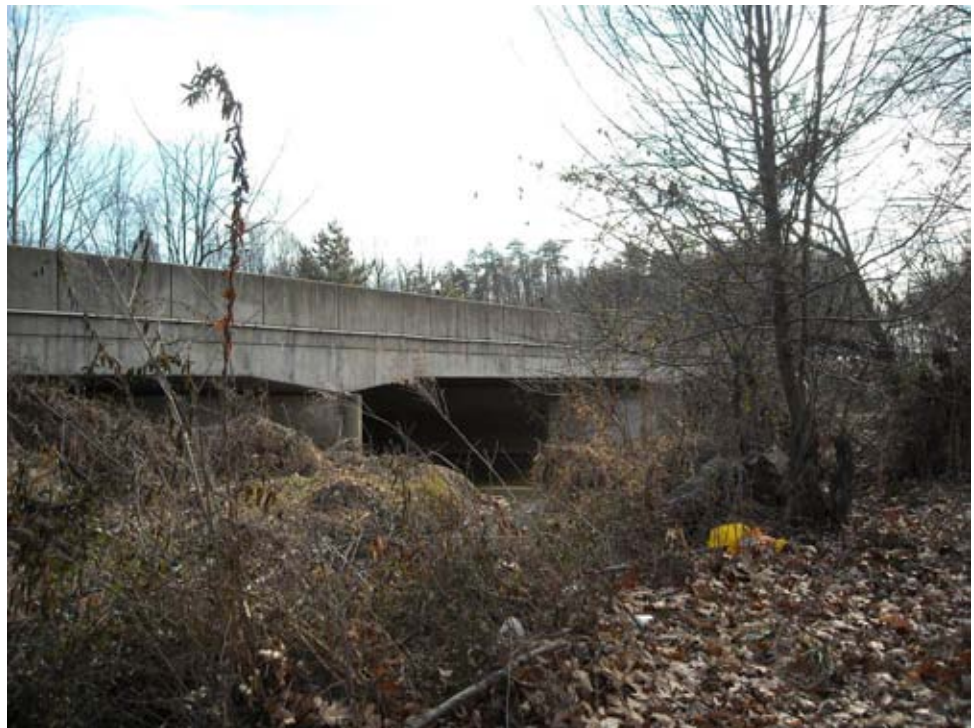
Photo 8

Culvert under
Pickett Road.

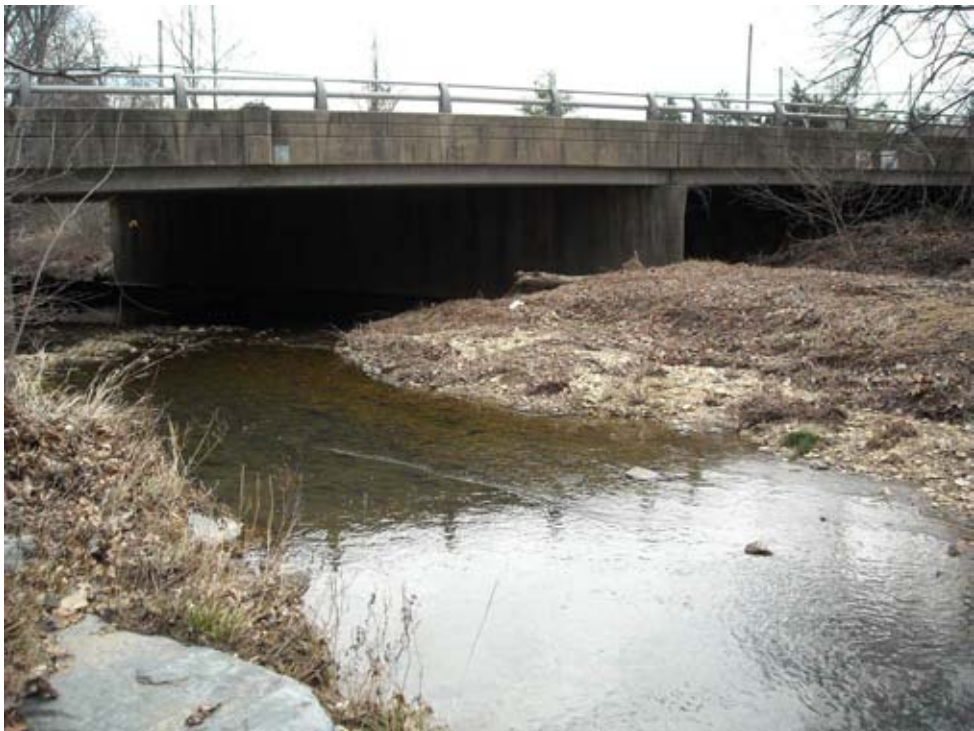
Foxcroft Colony Condominiums

Culvert under
Pickett Road.

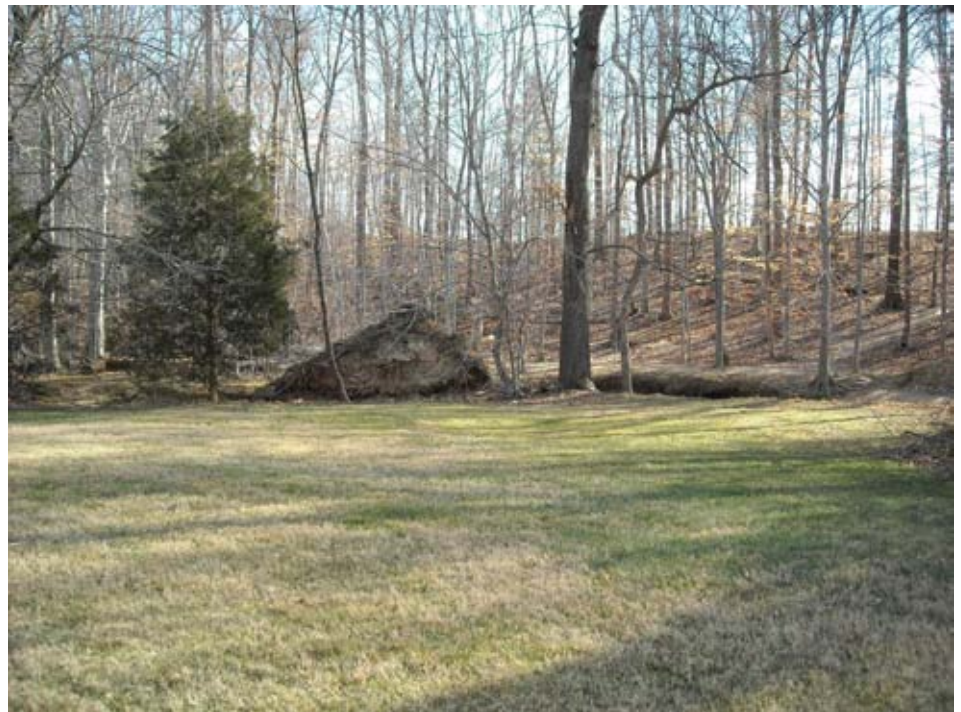
Mosby Woods Condominiums

Felled tree on the riverbank near the area impacted by inundation.

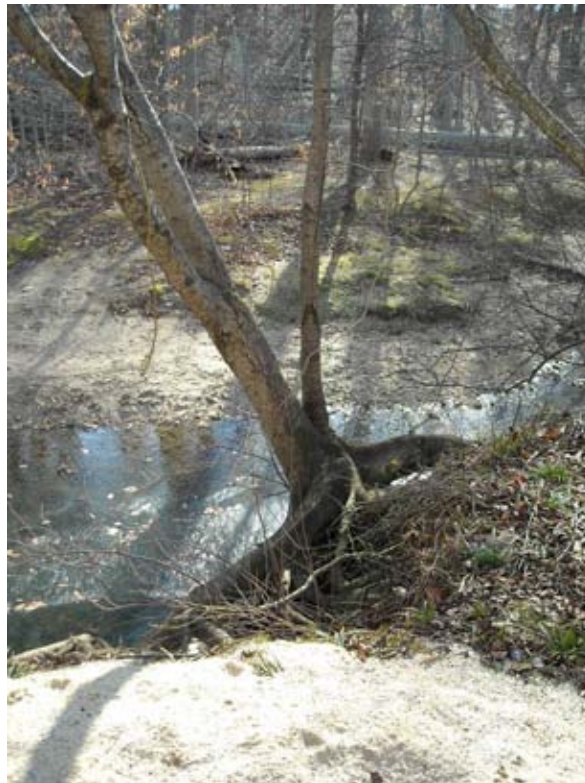
Mosby Woods Condominiums

According to a resident, this tree was planted at a distance to the river. The tree is now practically in the river due to changes in the riverbank over time.

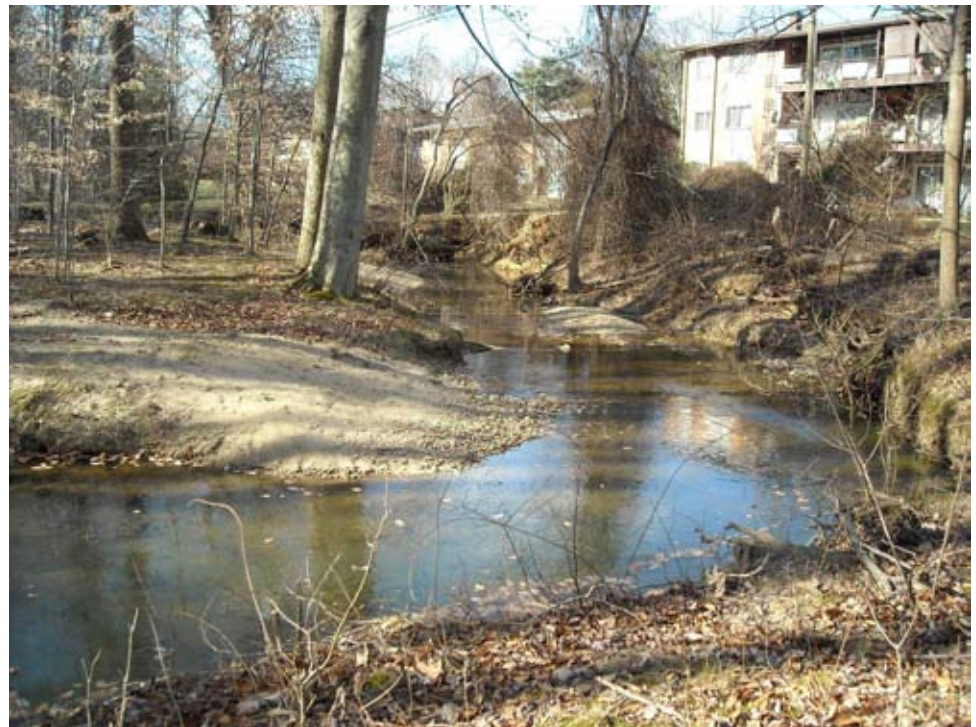
Mosby Woods Condominiums

Bend in the Accotink near the area experience flooding issues. According to a resident, in the past the river was not as close to the buildings but has changed course over time.
